**GENERAL SERVICES ADMINISTRATION
FEDERAL BUILDING, 517 GOLD AVENUE SW**

**ALBUQUERQUE, NEW MEXICO
PROJECT NO. NM0024ZZ**

BUILDING ENGINEERING REPORT

Building Name: Federal Building - 517 Gold Avenue SW
Building No: NM0024ZZ
Location: Albuquerque, New Mexico

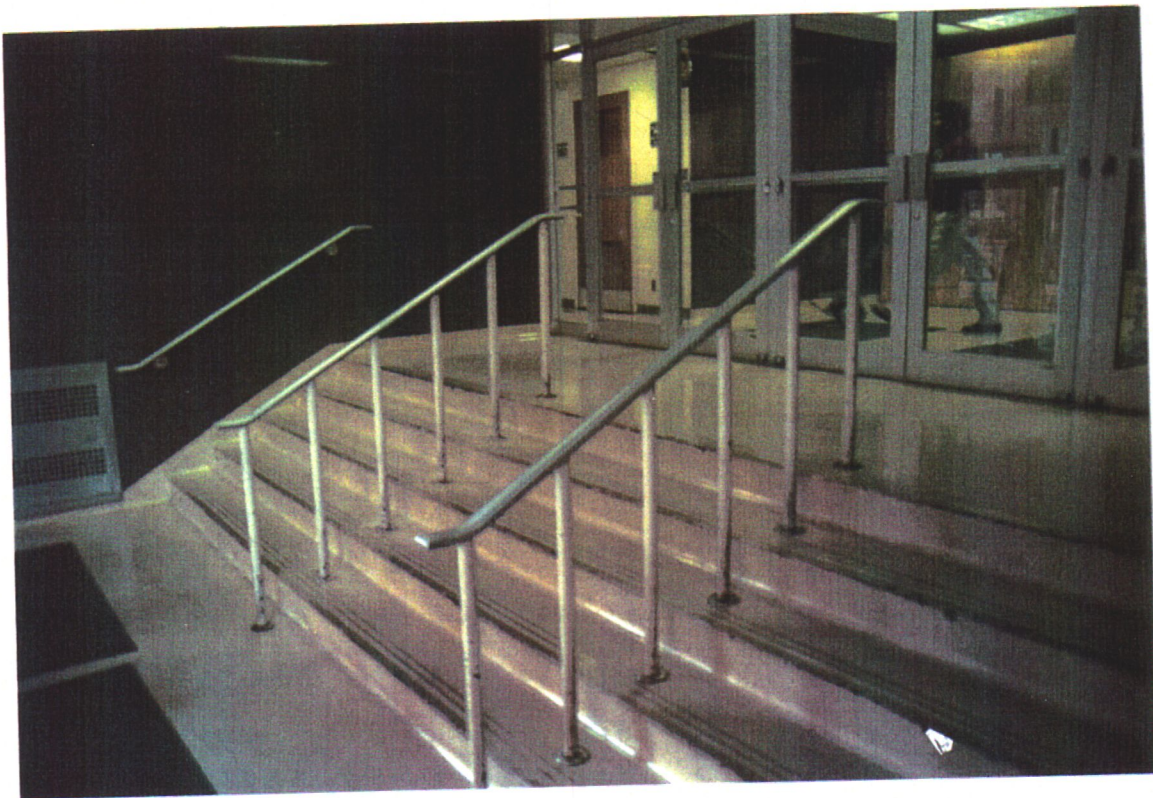
First Floor Lobby - Top Photo Looking North

The existing finishes in first floor lobby are original. They are plain, dated and are showing age. The walls are a very dark colored stone and the floor is a light color terrazzo. The ceiling is acoustical 2 x 2 tile with exposed grid. The entry doors/walls are glass with flat silver aluminum framing. The light level appears to be adequate but unattractive.

A modernization of the first floor lobby is required if the building is to remain competitive with other buildings and attract new tenants. The lobby colors are black/white and cold, with no color or attraction.

The recommended work would include; a new ceiling system, different ceiling heights and cove lighting using decorative tiles with minimal exposed grid. New light fixtures and spot lighting will be used to focus attention on artwork and lobby directory. The existing door will be replaced with a new anodized aluminum frame door system. The existing color scheme is black and white. The lobby needs color expressed in artwork and metal trims.
